# *Buyers Eyes Home Inspections LLC*

## Property Inspection Report

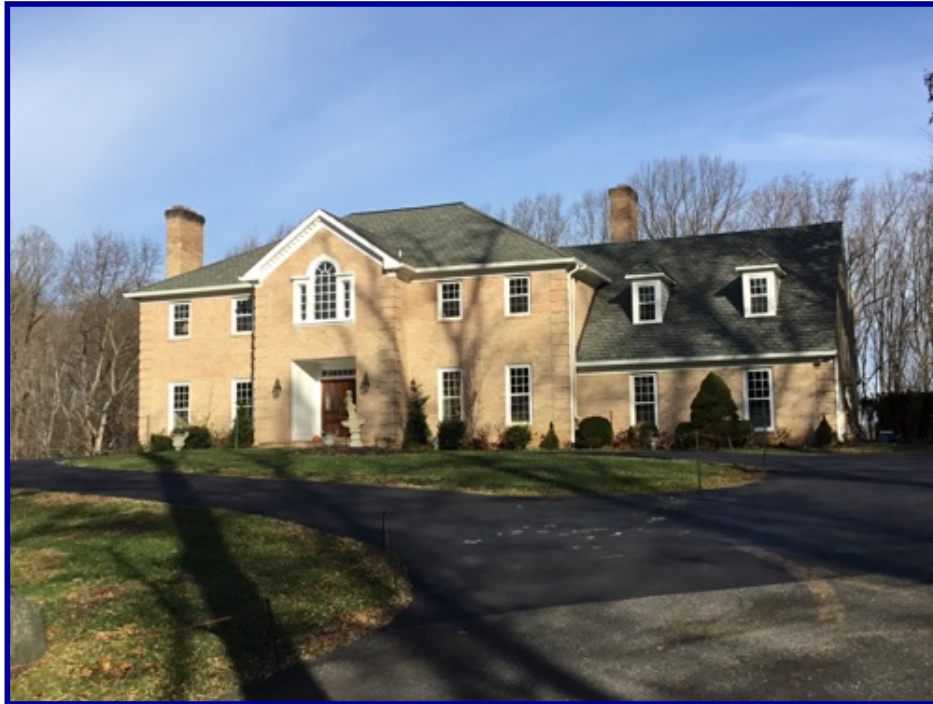
5 Cash Smith Road, Woodsboro, Md. 20854  
Inspection prepared for: Bob Smith & Sue Smith  
Date of Inspection: 11/29/2018 Time: 10:00 -2:00  
Age of Home: 1978 / 40 years old. Size: 5617 sq. Ft.  
Weather: Clear, windy. 35 degrees

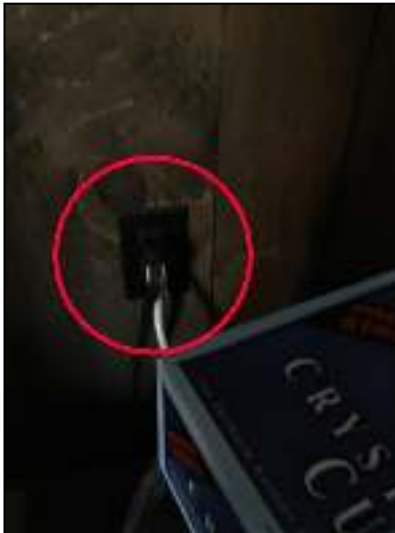
Provide GDCI protection on all outlets at bar area within arms reach of sink base.  
Eliminate the use of extension cords in this area.

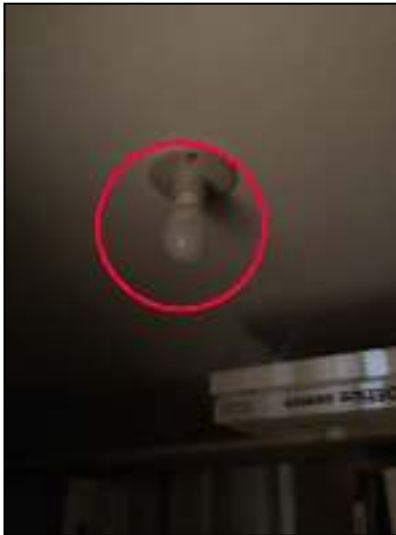
Install globe on basement storage room closet bulb

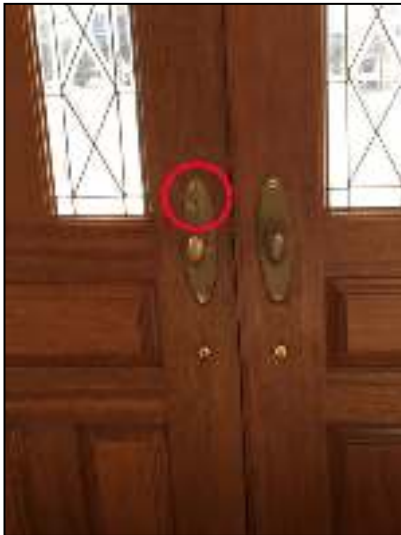
Remove keyed dead bolt on front door and replace with thumb turn. Safety issue.

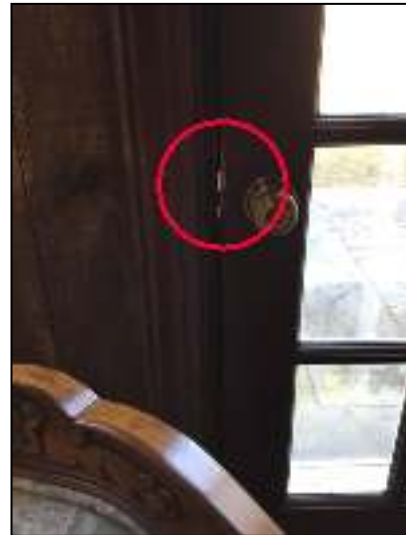
Provide tight seal around all back main level single doors to exterior.

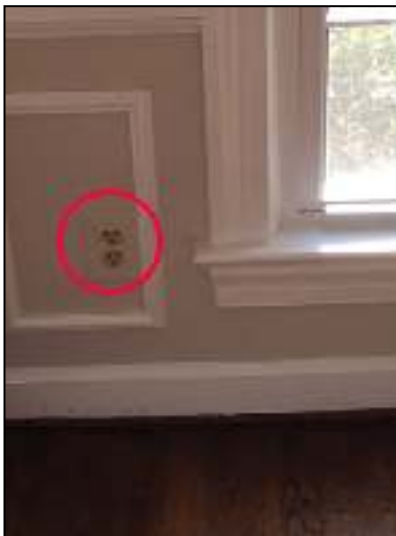
Replace two defective outlets in front right den area. Front and side wall.

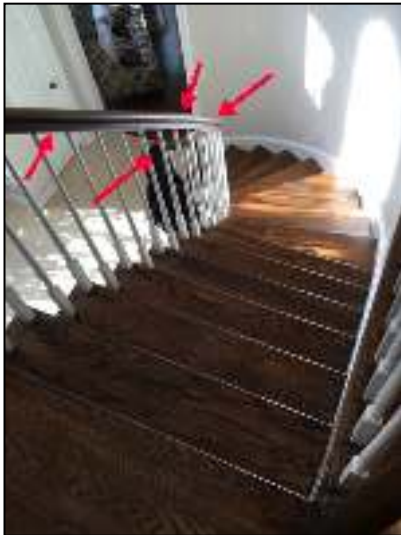
Secure hand rail at outside edge railing on main steps.

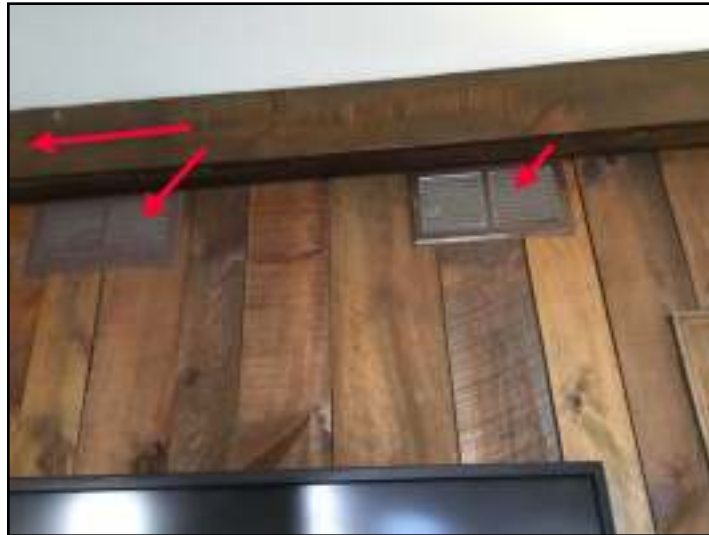
Have two return ducts cleaned in main level back right living room and properly protect exposed wiring at ceiling level.

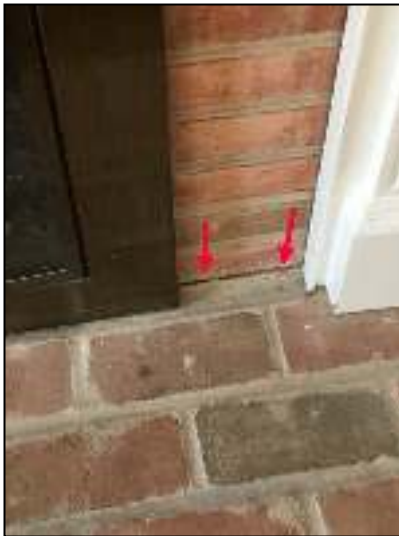
Repair mortar brick joint at fireplace both side in master bedroom. Properly insulate above recessed light above fireplace in attic area.

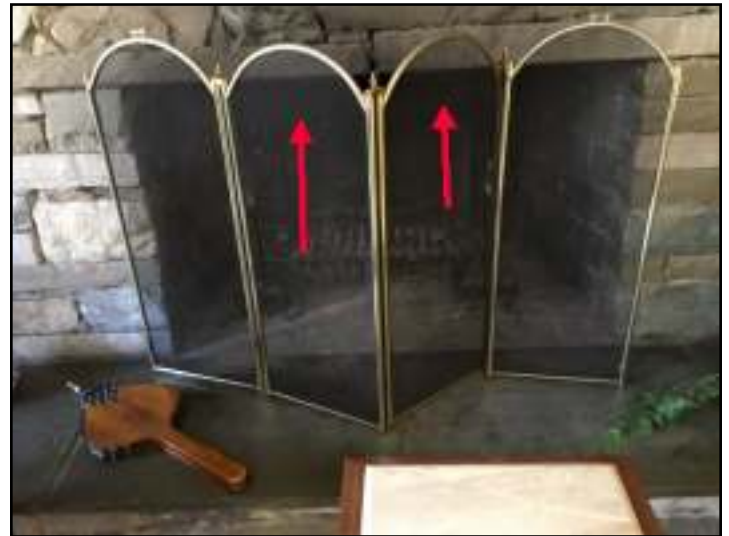
Interior flues of all chimneys need cleaned.

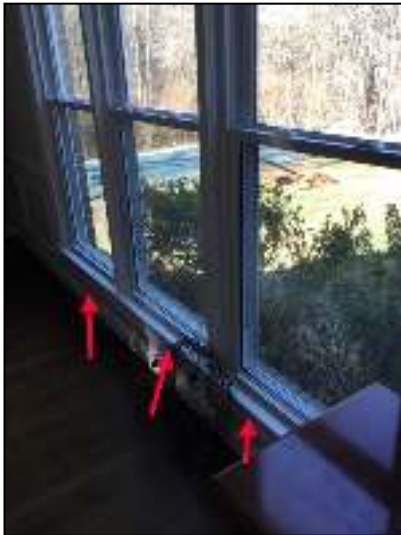
Several front and back main level windows are lower than 18" safety limit and need to be safety glass rated.

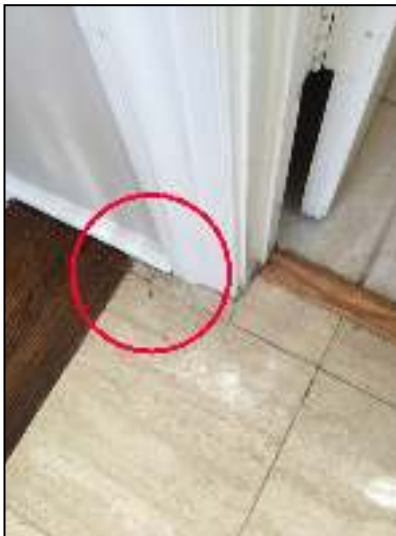
Repair tiles from main hall to kitchen left of door.

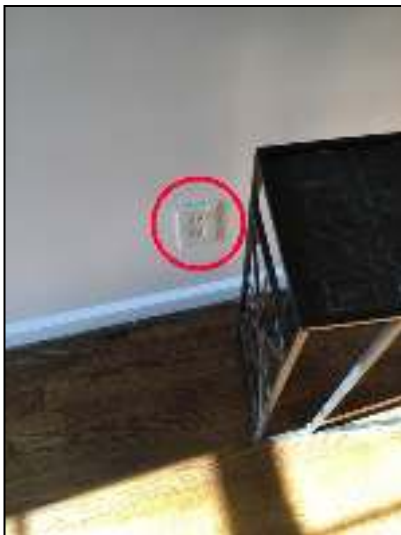
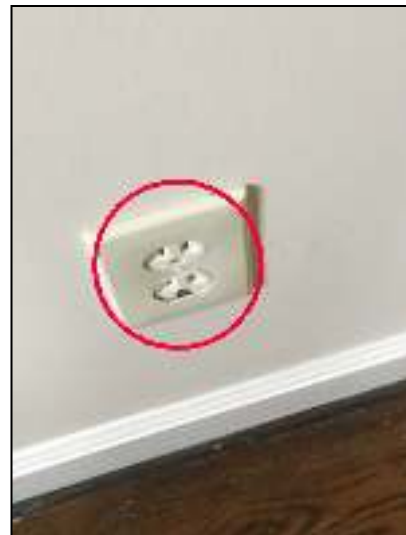
Repair outlet front top right room in front of door between closets. Several outlets have been painted over and are hard to plug in. Also loose in the wall.

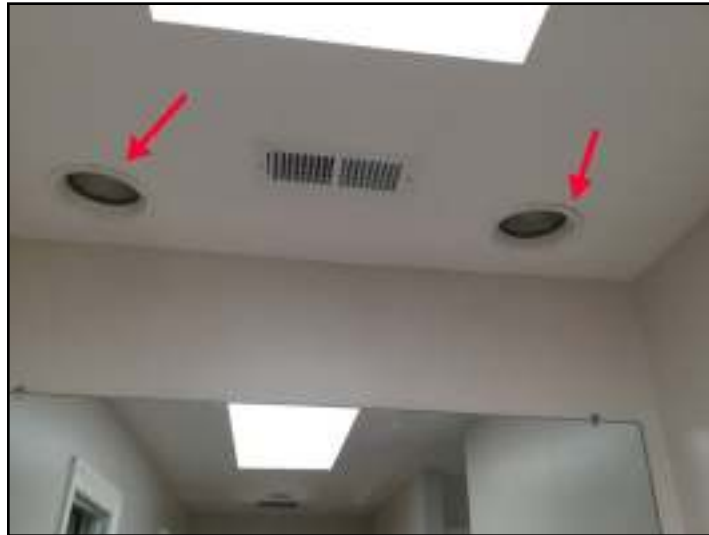
Secure recessed lighting in Master bedroom at makeup desk area.

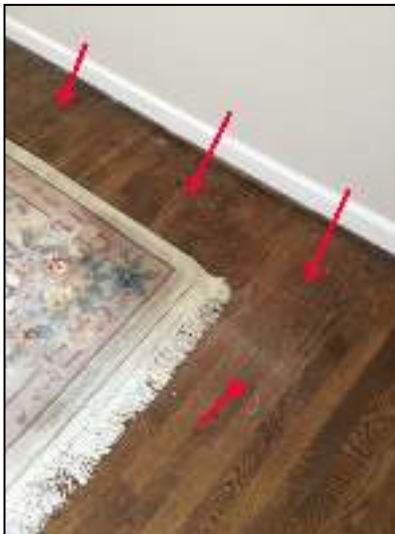
Repair hard wood flooring at top back right bedroom under windows.

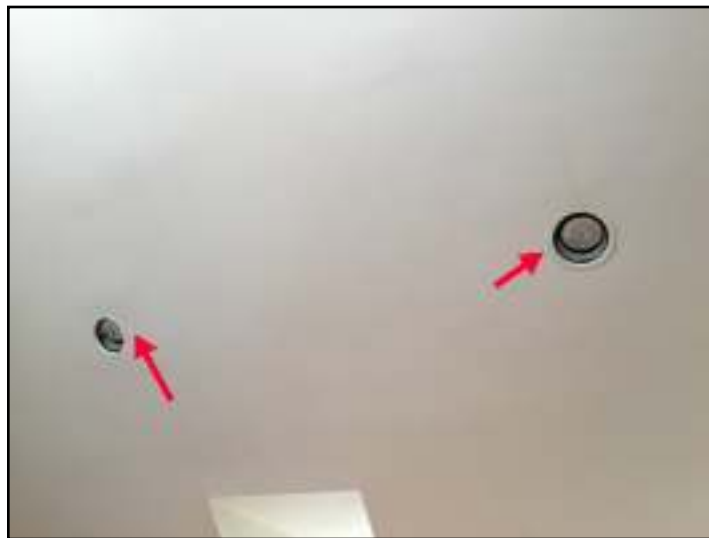
Properly insulate above recessed lighting in top right front office room.

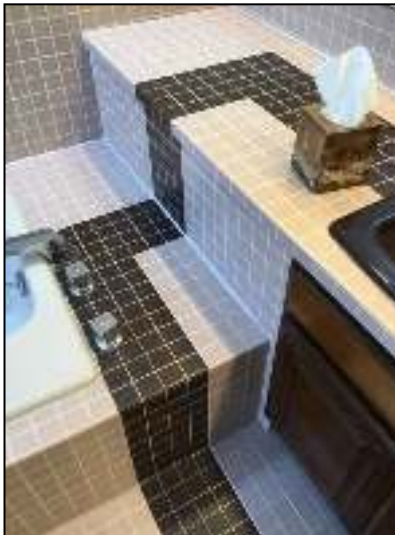
Repair several tile grout areas and caulk sinks to counter. Repair tile grout on floor tiles.

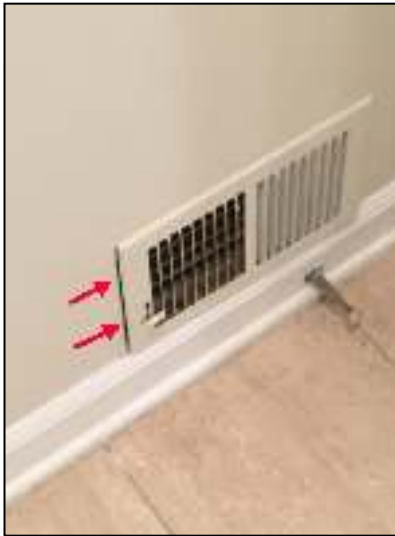
Repair vent in main level front half bathroom. Secure toilet to floor and tank to toilet.  
Repair sink stop. Have electrician provide one GFCI protected outlet at sink area.

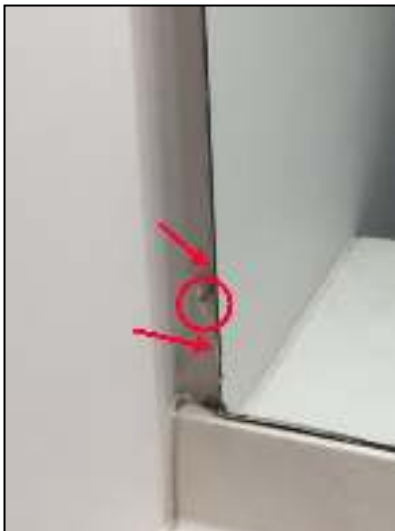
Properly secure mirror in top back hall bathroom

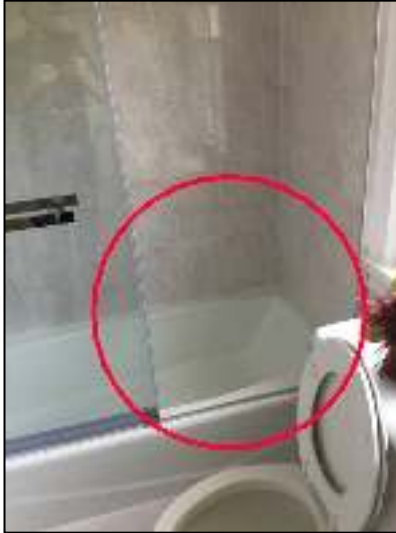
Change doors to provide proper access to shower area top right back bathroom repair heat lamp cover and recessed light trim. .

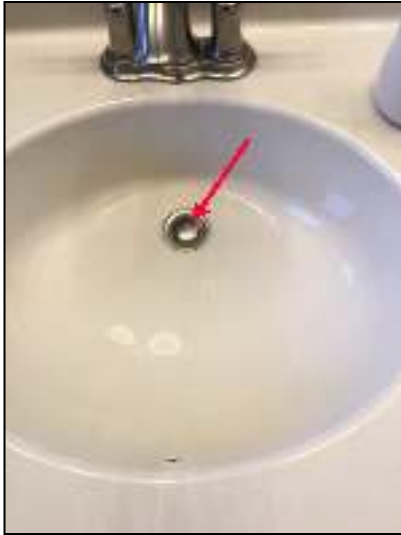
Repair drain stop top back hall bathroom. Back sink. Secure tank to toilet same bathroom. Repair ceiling at heat lamps. Caulk at tub to tile walls. Repair cabinet doors to close properly.

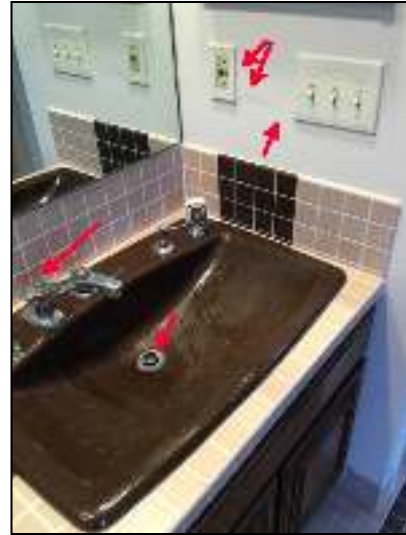
Repair drain stop on master left sink and repair wall at outlet right side. Inside of cabinet is wet at right side but sink not leaking.

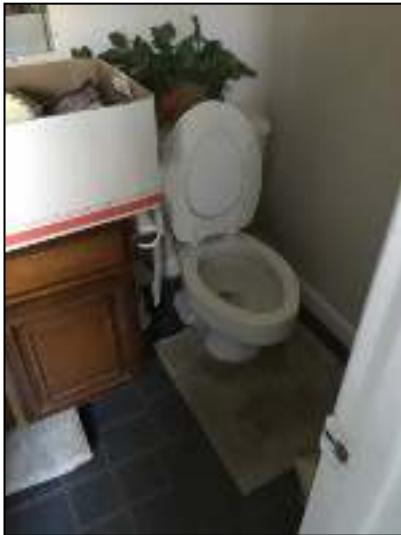
Replace toilet interior parts in main level laundry bathroom. Replace old ceiling exhaust fan. Have electrician install one GFCI outlet at sink area.

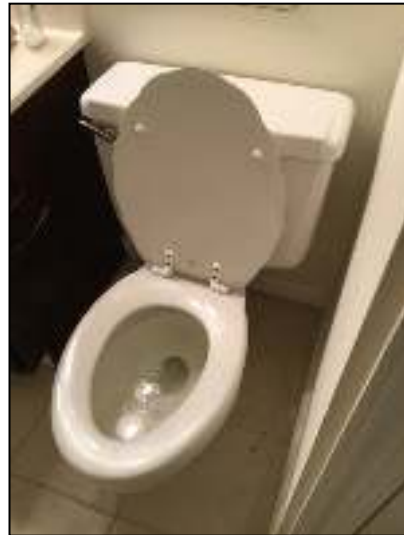
Secure basement tank to toilet. Repair shower drain and leaking shower head. Replace old sink GFCI outlet.

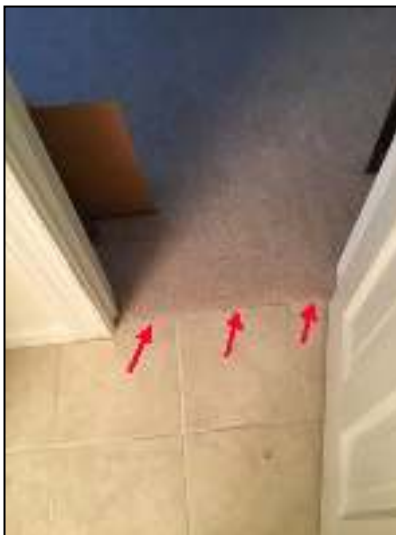
Provide transition strip at basement bathroom door to carpet.

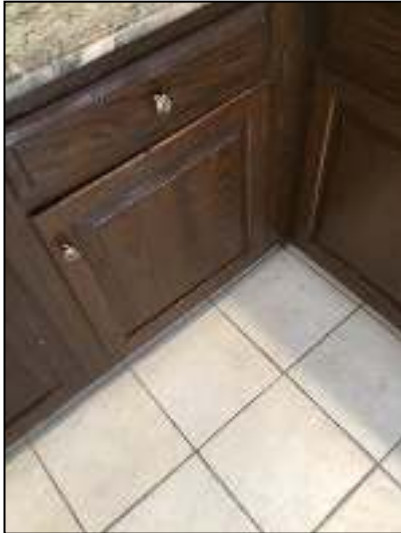
Repair hardware on several kitchen cabinets.

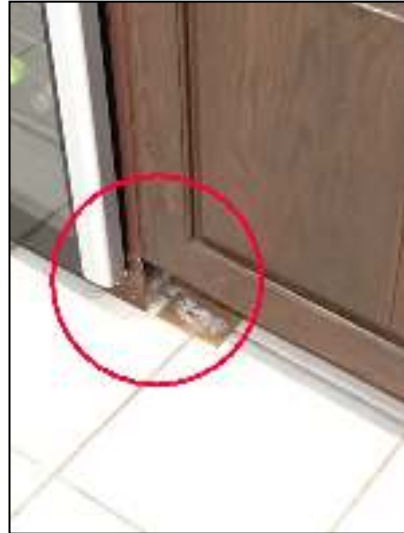
Replace damaged base trim at wine fridge left of kitchen cook top area.

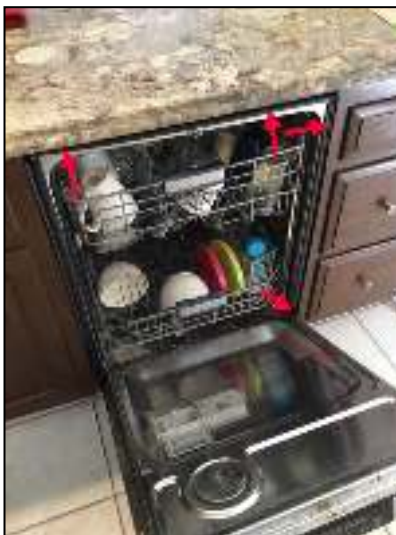
Secure dishwasher to cabinet or counter. Repair right door seal.

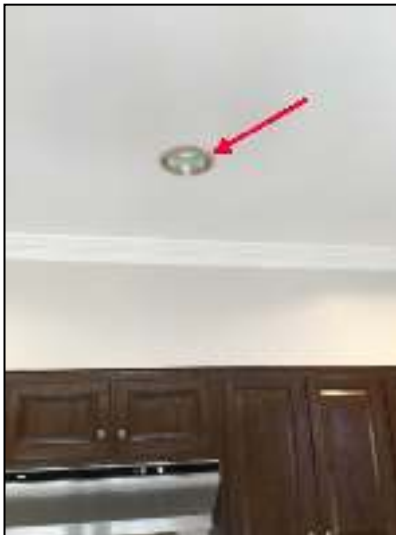
Repair light above kitchen area.

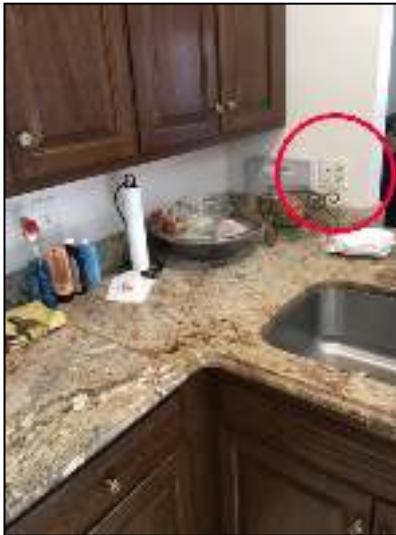
Provide proper GFCI protected outlets around kitchen area as required. All outlets.

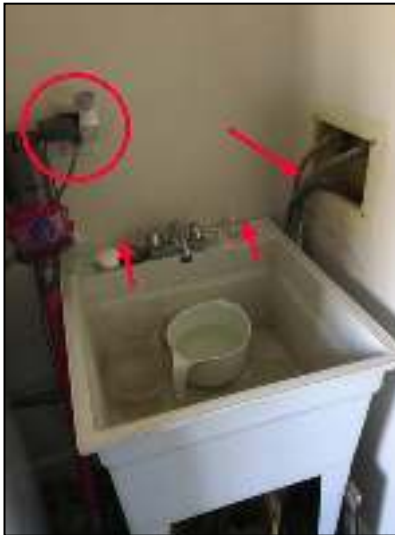
Provide GFCI protection at laundry sink. Replace old washer hoses. Secure sink to floor or wall. Seal opening in outside wall under sink.

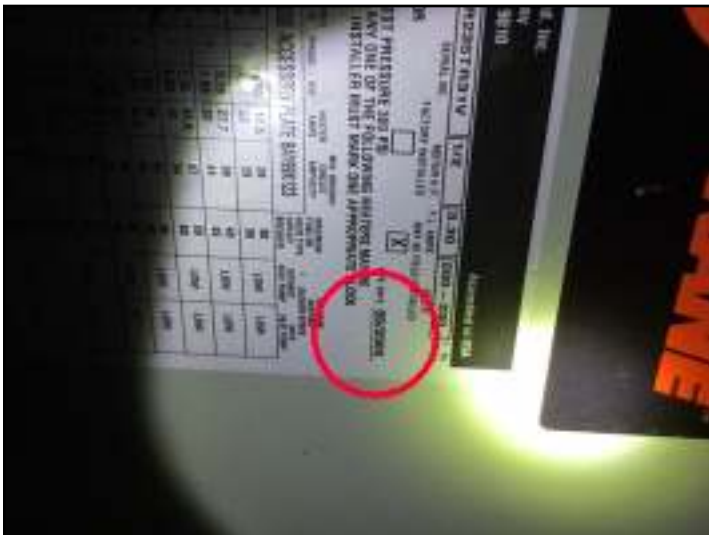
Attic air handler for heat pump is 2000 model in fair condition. Have unit cleaned and serviced. Have bottom side of A coils cleaned by HVAC contractor. .

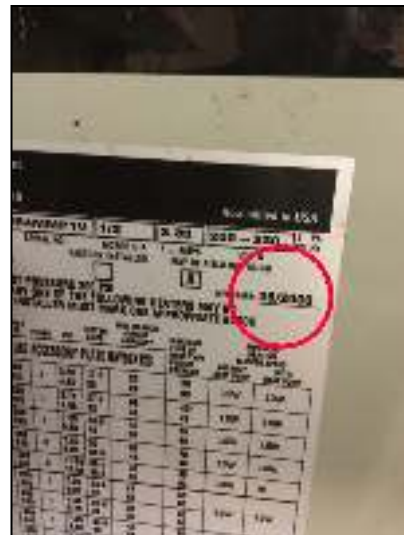
Basement air handler is also 2000 unit in fair condition. Have unit cleaned and serviced. Have bottom side of A coils cleaned. Have humidifier cleaned and serviced.

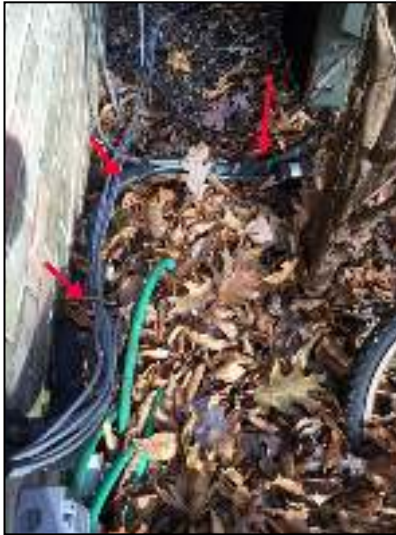
Replace all damaged insulation on refrigerant lines at condenser units.

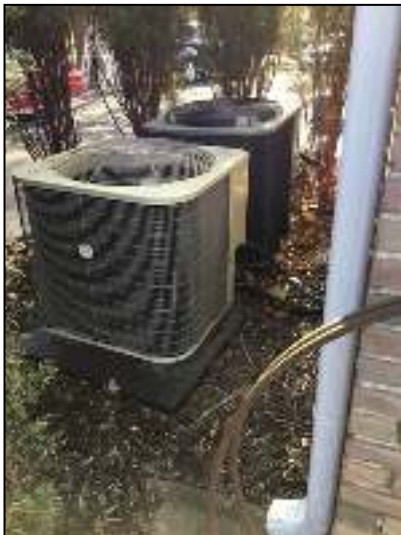
Heat pump units are both 2013 models in good condition. Have both units cleaned and serviced. Provide level pad for both units.

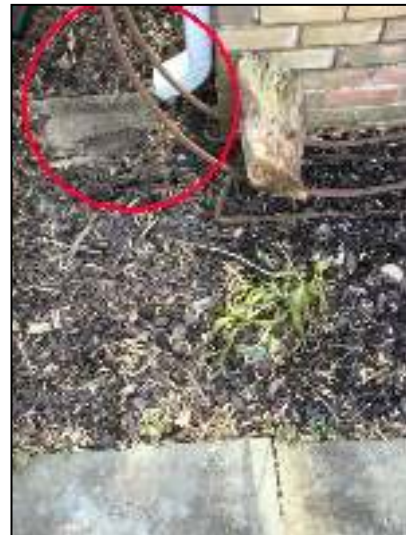
Raise grade and splash block and back left corner to get water away from foundation.

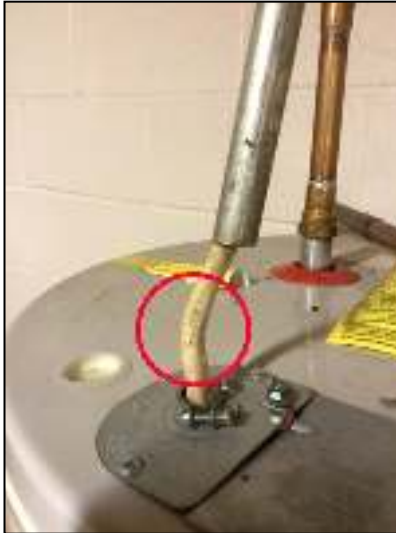
Water heater is 2010 unit in good condition. 80 gallons. Replace damaged wiring at connector at top of heater. Properly secure wiring to floor joist to water heater.

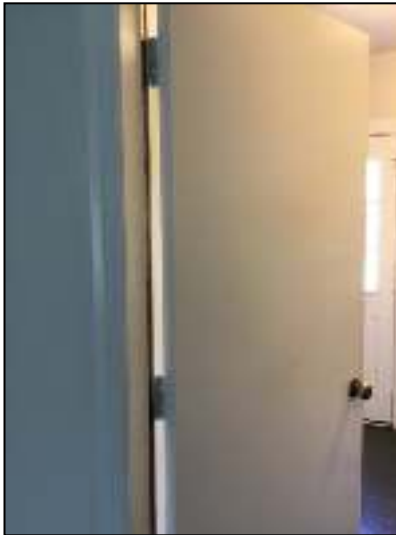
Install two self closing spring hinges on door from garage to house for fire safety. Door should self close and latch. Seal wall at refrigerant line penetrations in garage. Repair fire wall at bathroom side around pipe for fire wall seal. Install safety beam sensors on garage doors to exterior as required.

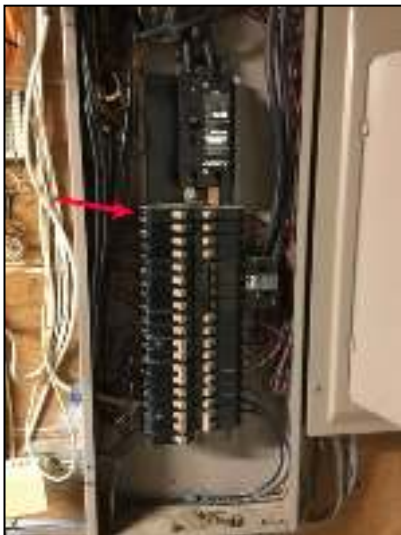
Have electrician provide proper GFCI protection on all power to pool area, including pump. Provide proper ground bonding from driven ground rod. Eliminate double tapping on non approved breaker top left breaker left panel.

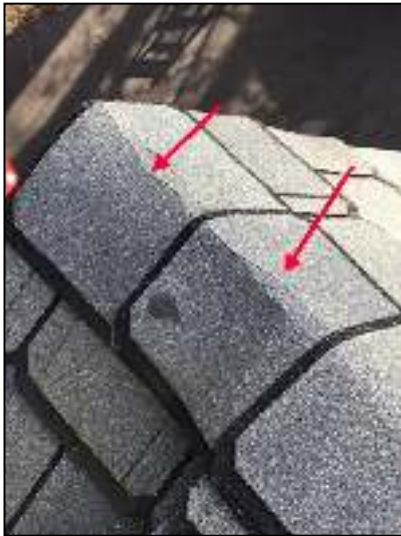
Replace damaged cap shingles right end of house on top peak end

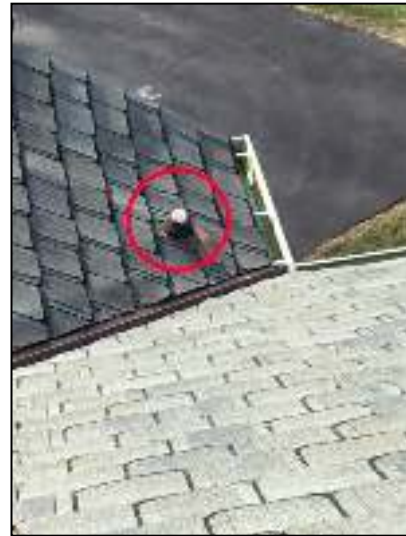
Extend front left plumbing vent on roof to 10" minimum.

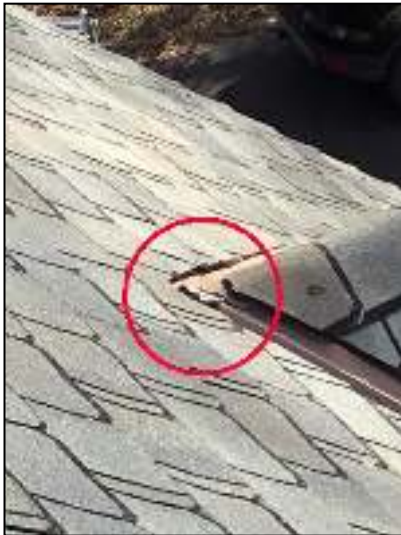
Seal metal terminations at top edges of dormers on front garage area.

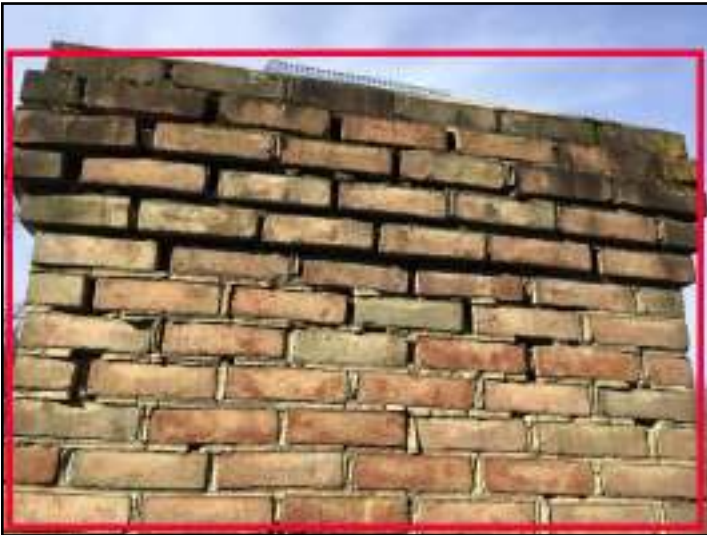
Repair all deteriorated mortar joints on both chimneys at top 4ft of bricks

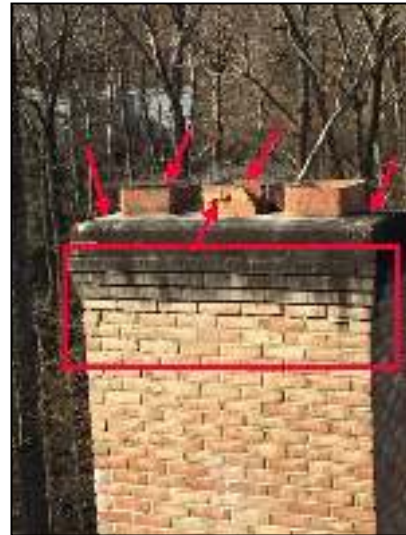
Replace damaged flue and top cap screening on left chimney. Also repair mortar joints around top 4ft section. Repair both chimney top cap concrete.

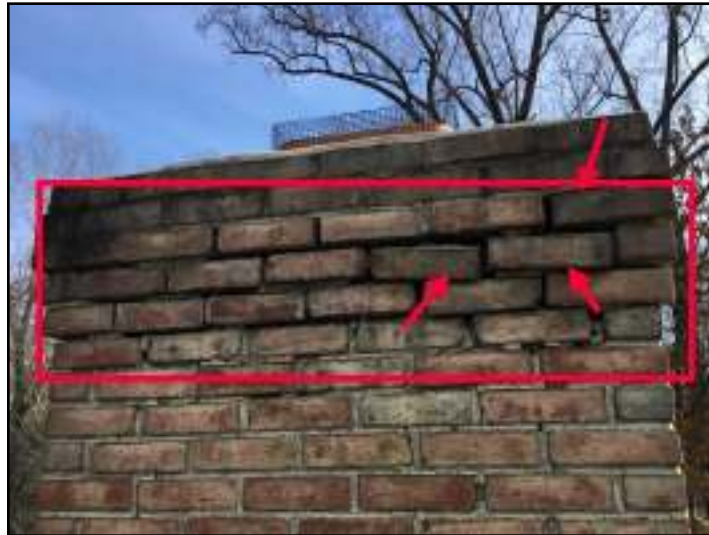
Bricks are actually falling out at the left side of middle chimney top section.

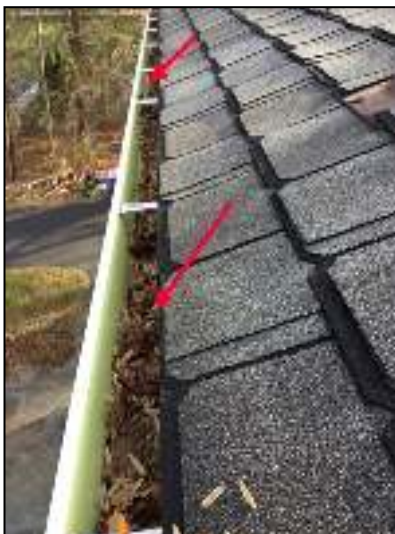
Clean all gutters. Full of debris.

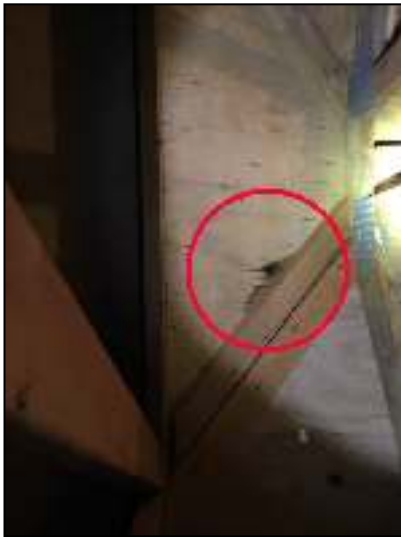
Repair minor roof leak at right of attic air handler, right top peak area.

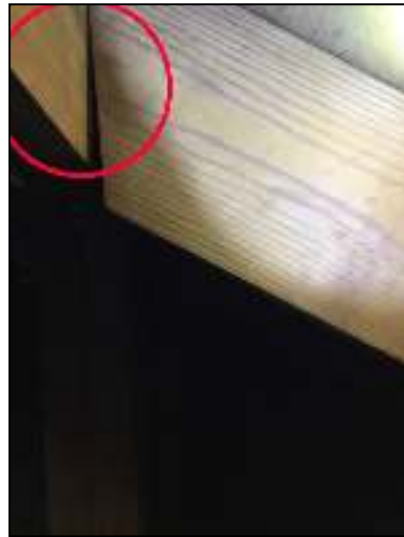
Properly secure all hip roof rafter ends right end of attic at rafter ends. Several terminations. .

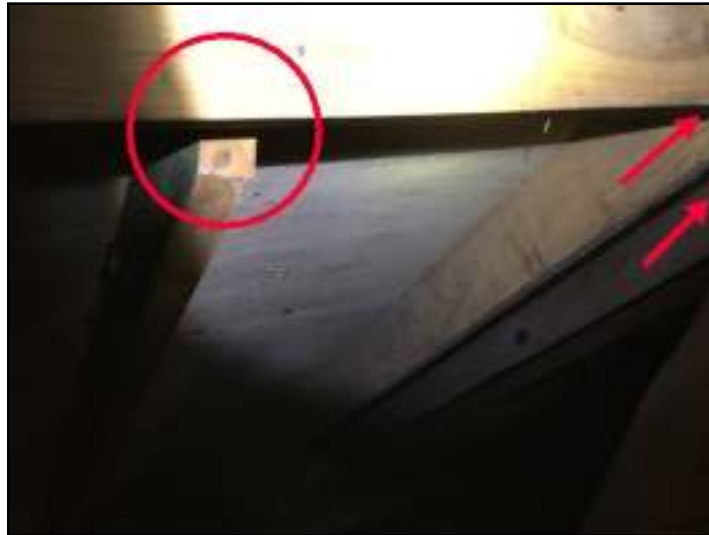
Secure top ends of all these terminations as noted previous.

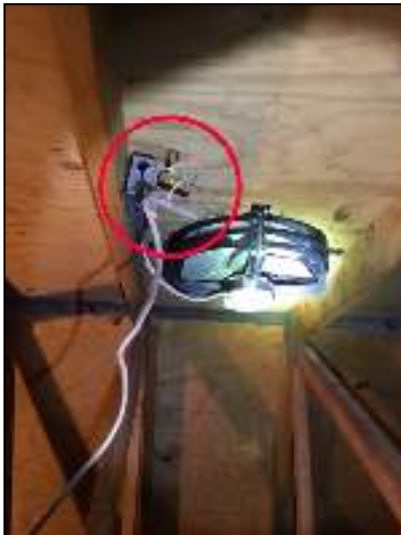
Have electrician properly wire attic fan.  
Could not get to operate.

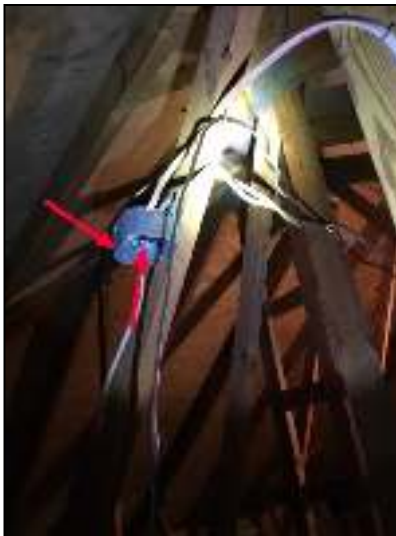
Close all open junction boxes in attic space.

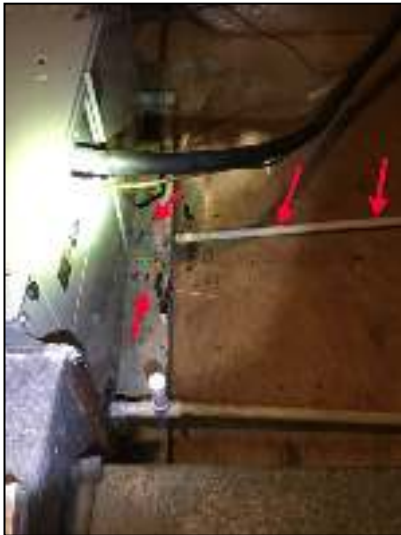
Repair drain pipe from heat pump in attic to flow properly. Clean pan area.

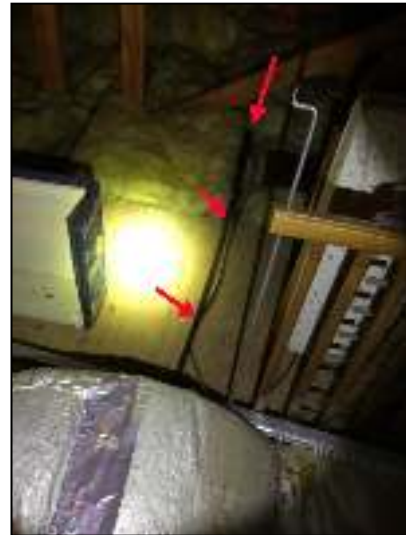
Remove abandoned refrigerant lines behind attic unit through floor to basement from attic.

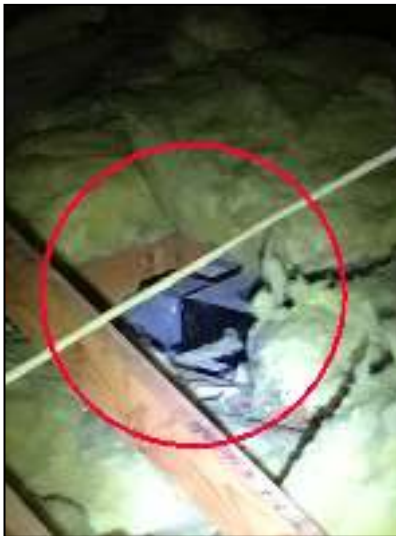
Bathroom fan terminates into the attic space. This needs extended out to wall with vent cover or through roof to prevent moisture in the attic space. Properly insulate above all fans and recessed lighting throughout the attic area. Several locations.

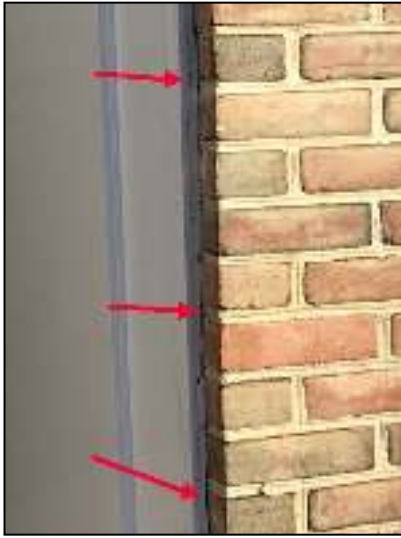
Caulk all wood to brick transitions.

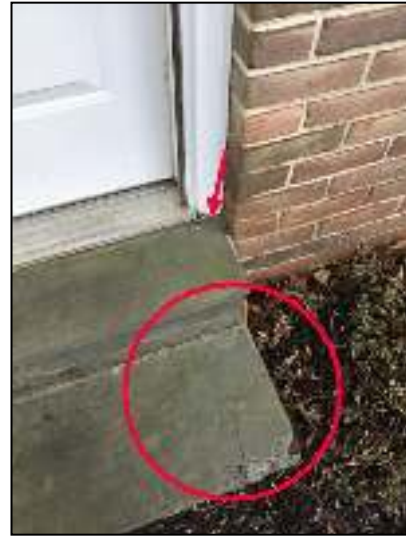
Repair stone steps at back left garage door.

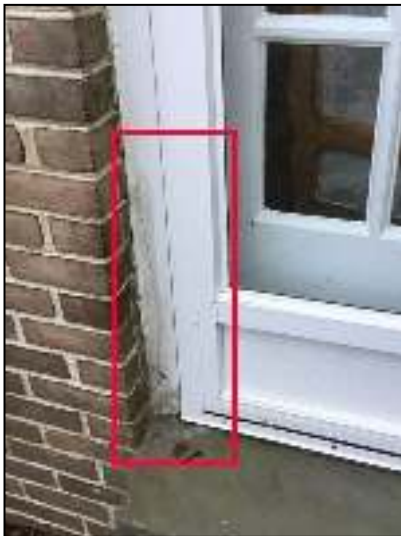
Replace rotted trim at back right single door

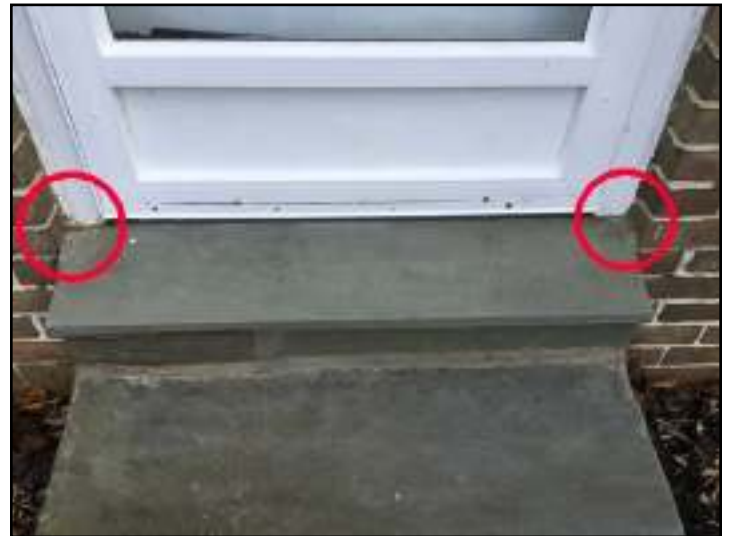
Seal sides of back center door step stone areas several locations.

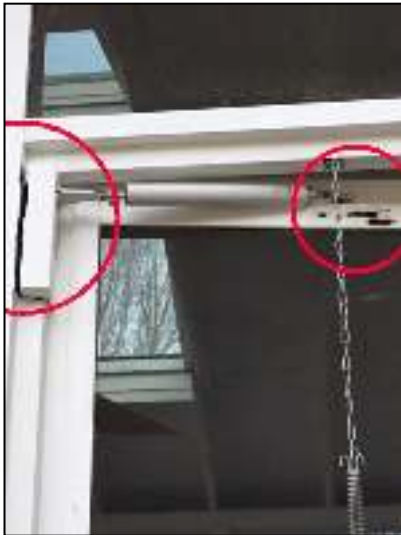
Replace back enclosed porch door and trim area that is rotted.

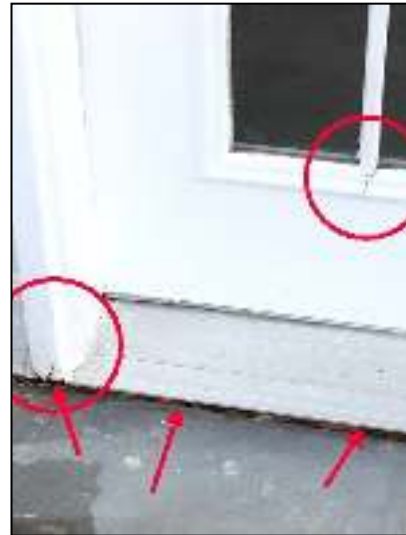
Replace rotted wood trim around left end lower level door and repair or replace damaged door. Caulk brick to trim areas.

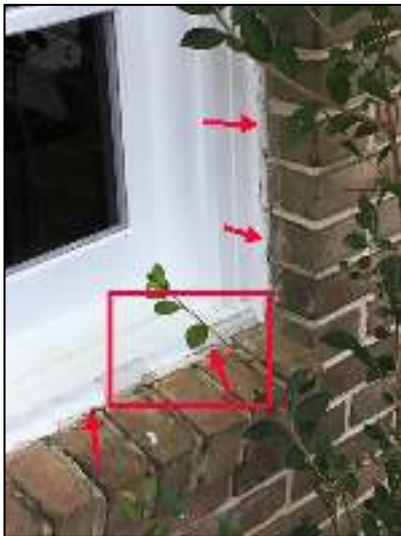
Re caulk at all doors and windows to brick transitions. Replace rotted window trim

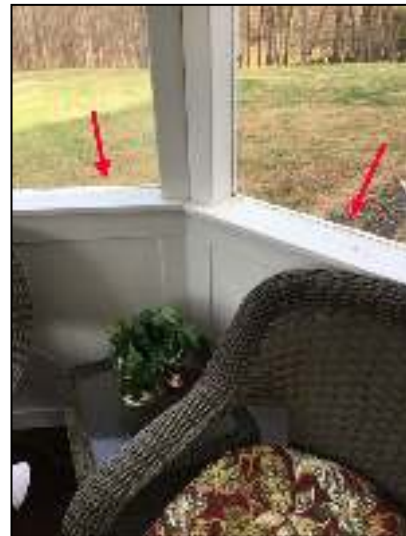
Replace all damaged screens around back porch enclosure.

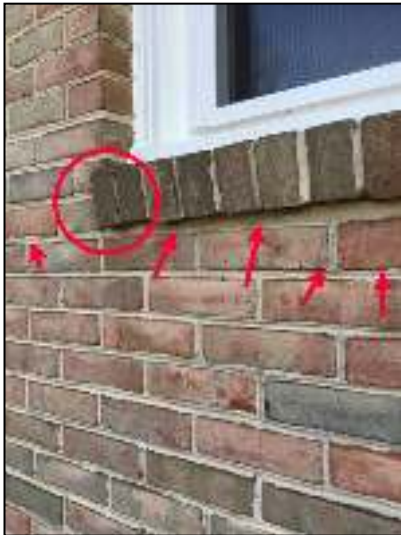
Repair brick joints at back top left single window area. And at top right corner of same window.

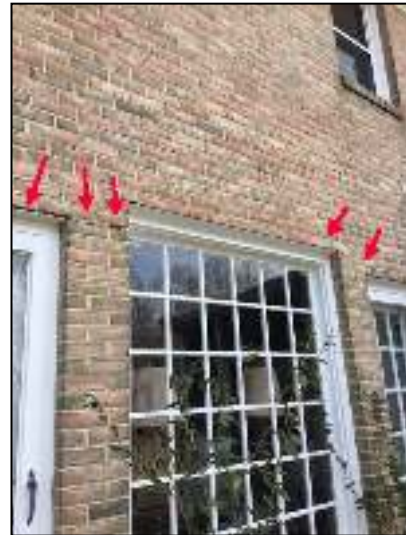
Repair brick joints above back door and window corners.

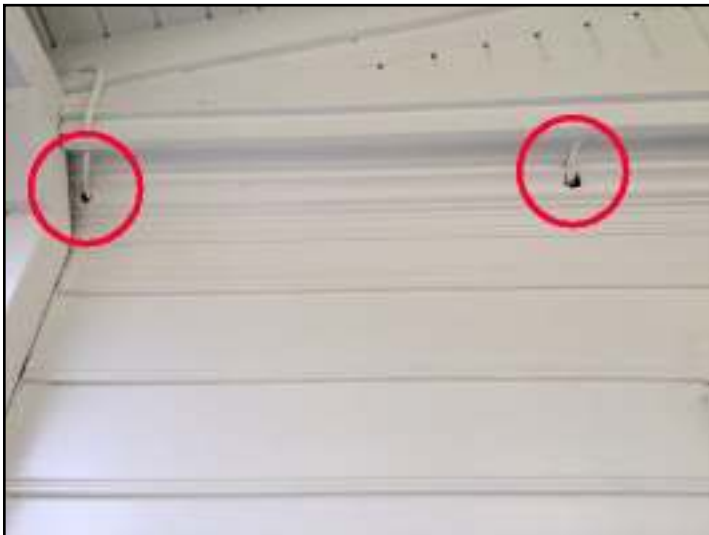
Seal openings at wires above back porch enclosure house end.

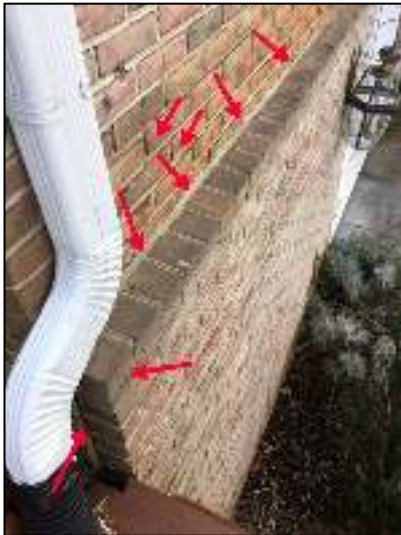
Repair crack at top edge area of brick to lower level. Left end.

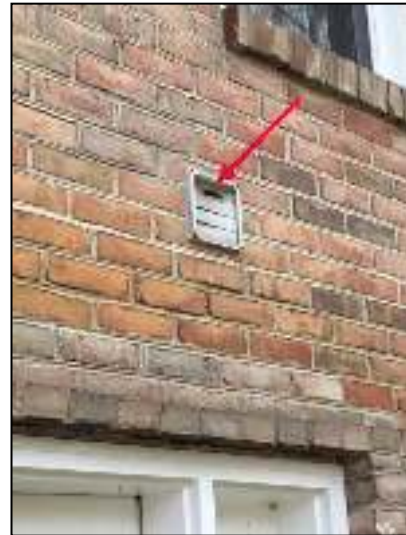
Replace damaged vent cover at left end wall

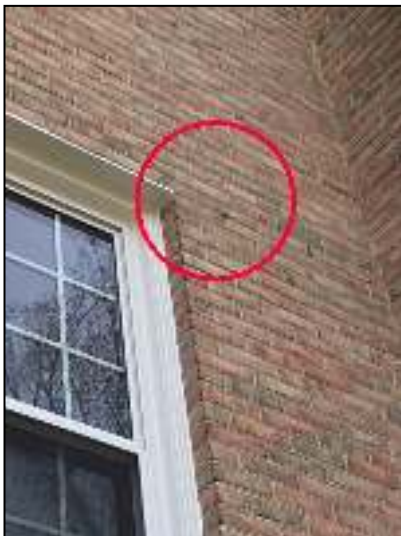
Repair brick joint left end above right side of second level window.

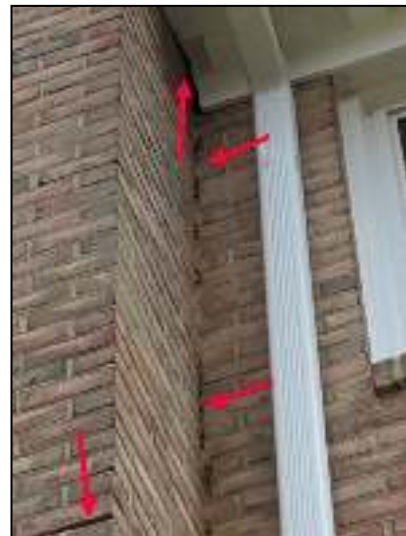
Seal gap at left end chimney to house area and at soffit this area. Repair brick joints at left chimney base cap area left end. seal opening at soffit ara.

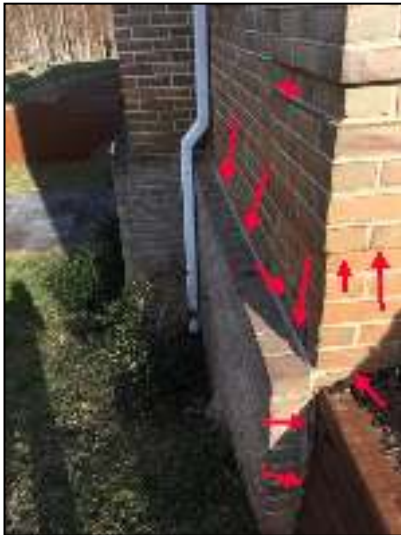
Repair brick joints at left end lower level front left corner.

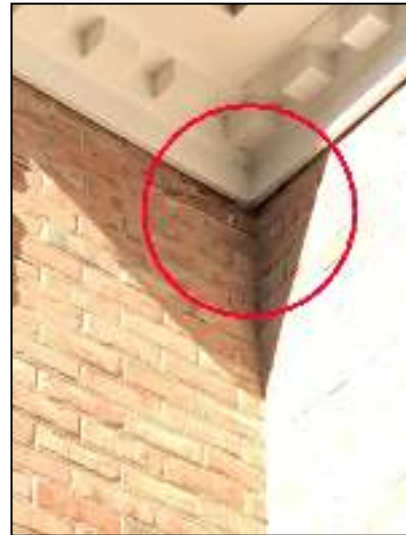
Repair brick joints at right side of front porch at eave and seal opening.

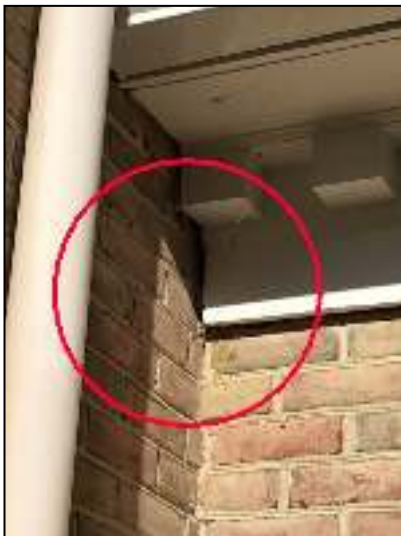
Seal opening at brick to lower eave area front left of garage to house corner.

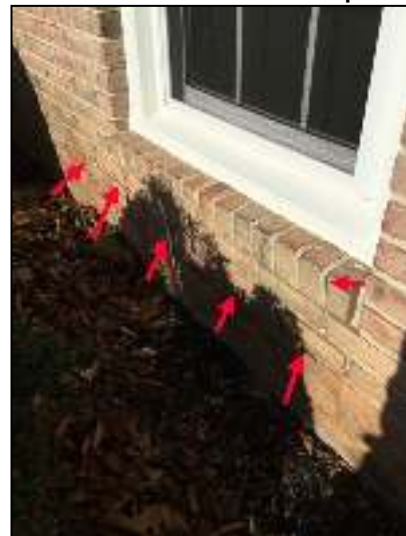
Repair large open brick joint on front of garage wall under front left window and above right front garage window. Right corner of window.

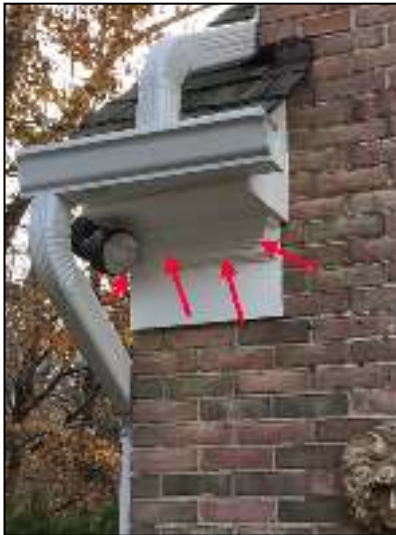
Replace rotted wood at right side back corner.

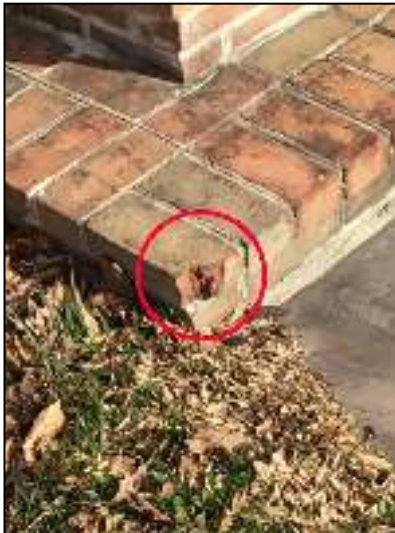
Replace brick brick at front left entrance area.

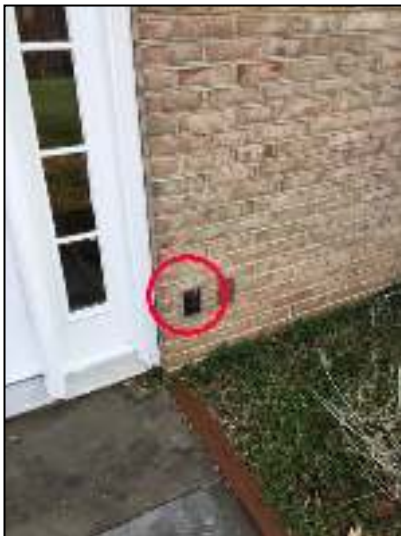
Replace bad GFCI outlet left end Lower level.

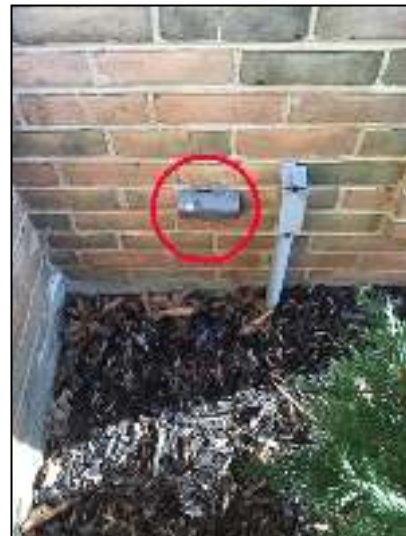
Replace front left of front porch area GFCI outlet and one at back patio area that do not reset.

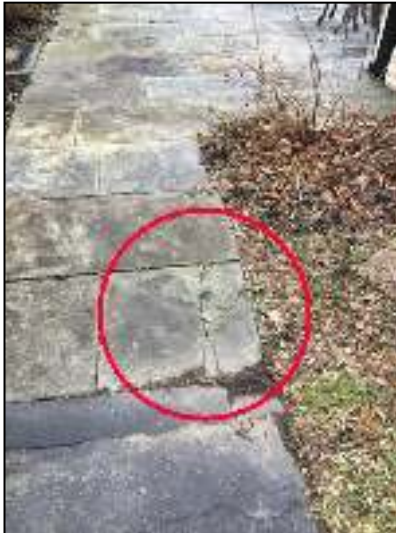
Replace broken stone on back right corner at patio.

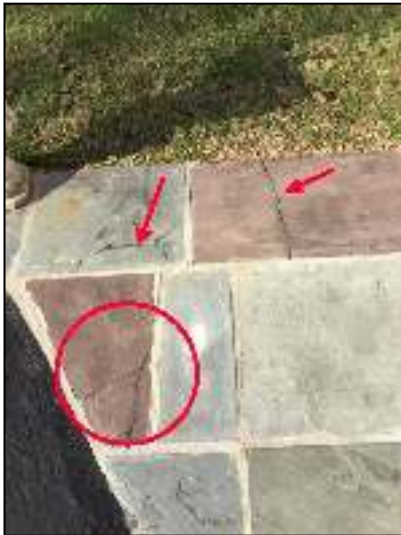
Repair cracked stone at front entrance.  
Left side.

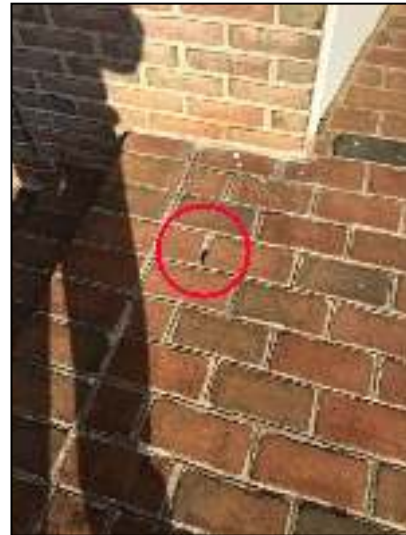
Repair brick joint at left of front entrance.

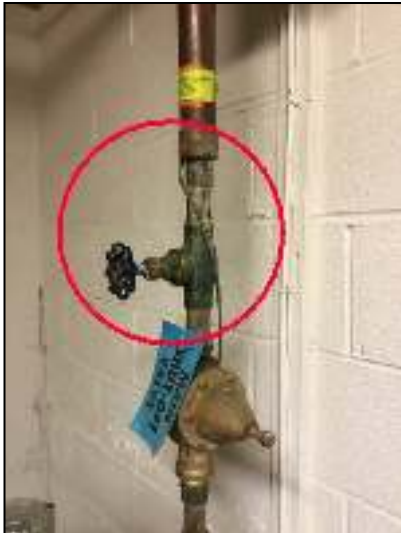
Repair leaking valve at main water line.  
Seal wall penetration.

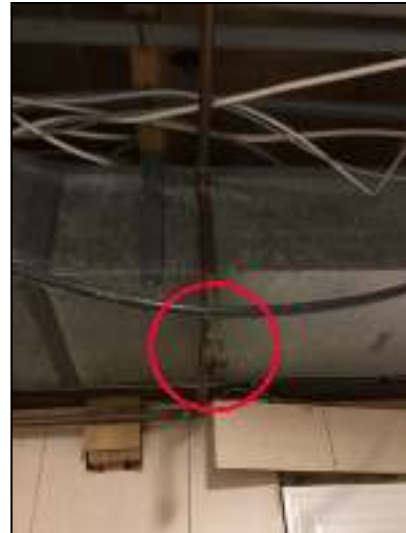
Replace leaking plumbing cap above main  
electric panels.

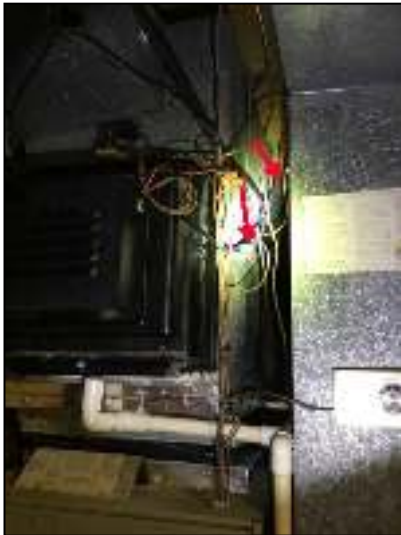
Install outlet for humidifier to eliminate extension cord.

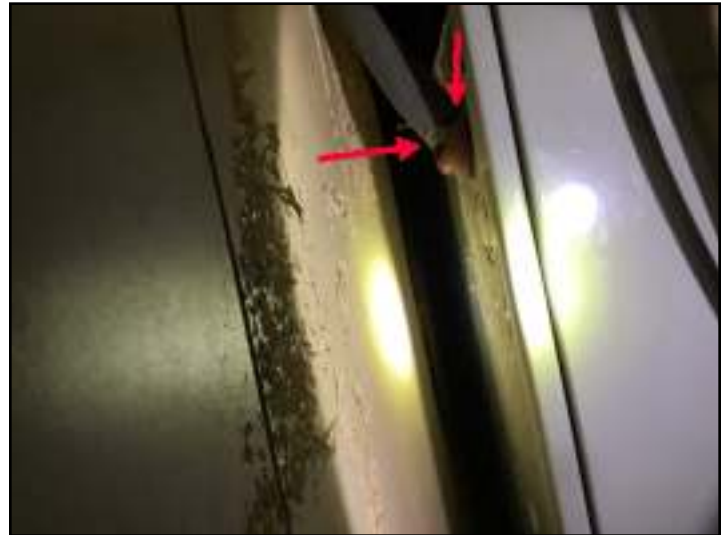
Install proper electrical connector on furnace in basement. Left side.

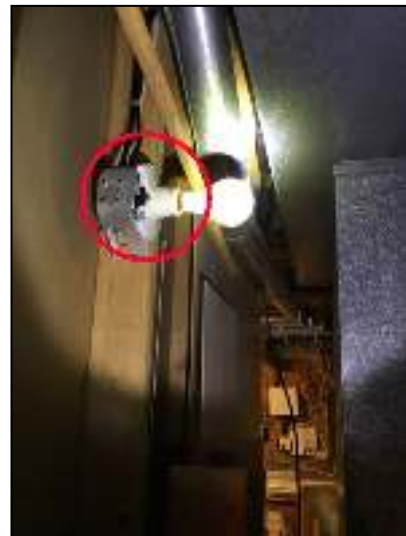
Replace damaged fixture and install globe on bulb behind basement furnace area.

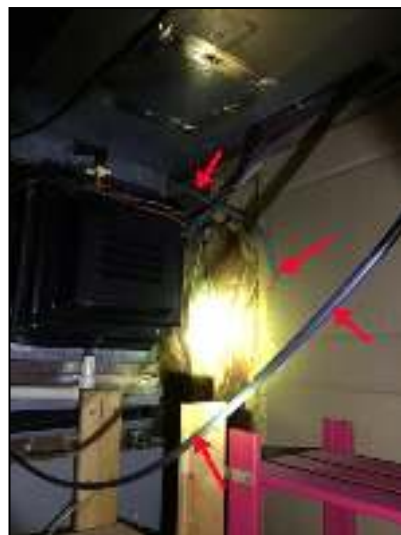
Remove all abandoned electric wiring behind furnace area and at left of main panels
